FIELD SERVICE REPORT

Heat and Control, Inc. 21121 Cabot Blvd. Hayward, CA. 94545
Phone 510-259-0500 Fax 510-259-0600

Report Number DB013124

Equipment/System: HWF-3618 fryer CTHX-2.5, DPF-2724 and CBF-36 SO Number: 202002586

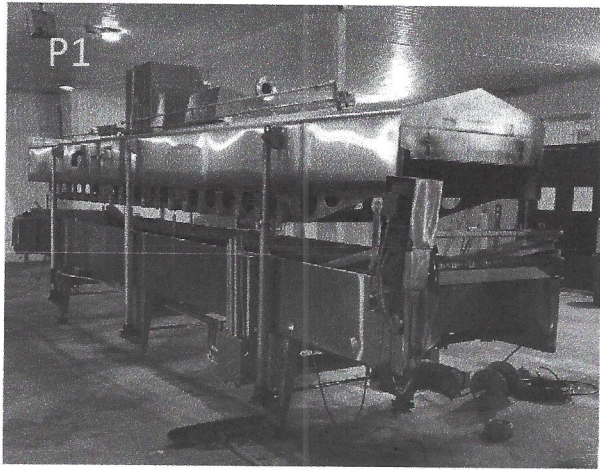
1. The hoist and jack system looked in good condition, on our arrival the hood was in the up position. The hoist position switches were all intact. Reference photo P1.

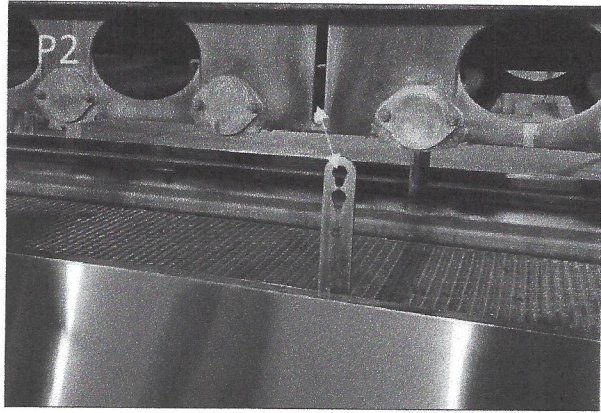
2. The conveyor belt, motor and shafts were in good condition, with the exception that the conveyor frame was shifted forward and disconnected from the frame. This will need to be realigned with the hood and pan before entering operation (bolt conveyor keyhole into upper slot in frame). Reference photo P2.

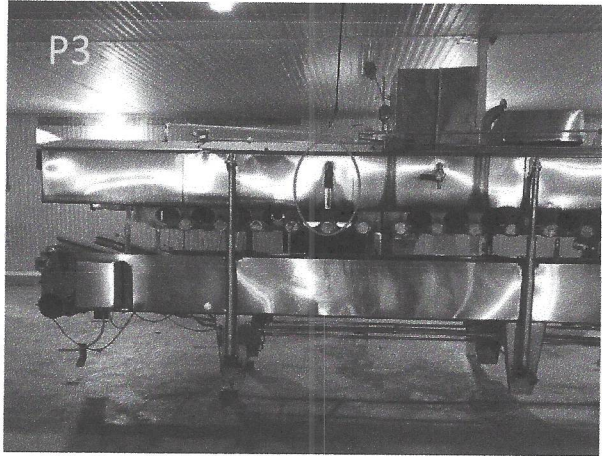
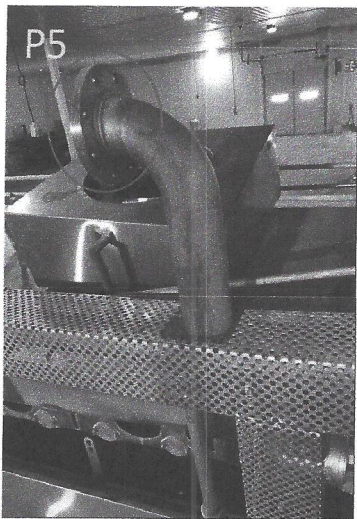
3. Flow Weirs, CIP Nozzles and flow Valves were all in place with the exception that the flex hoses that service these manifolds were missing. The CIP drip pan was found loose underneath the hood. Reference photo P3 and P5.

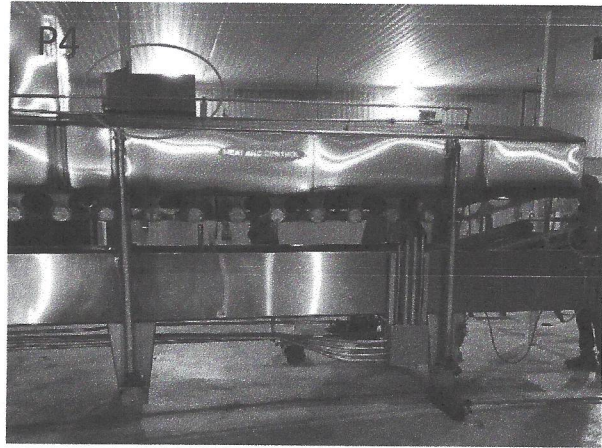
4. The hood condition was good with no signs of major bowing.
5. The fryer Mist Eliminator section was there but has been cut in half, so it will need to be rewelded. No replacement pads were found on site. Reference photo P4.

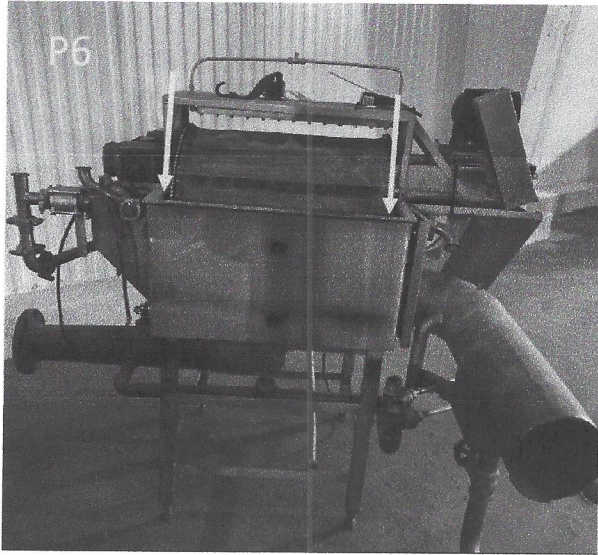
This DPF does not have safety switches for the removable covers. [Reference photo P6.](#)

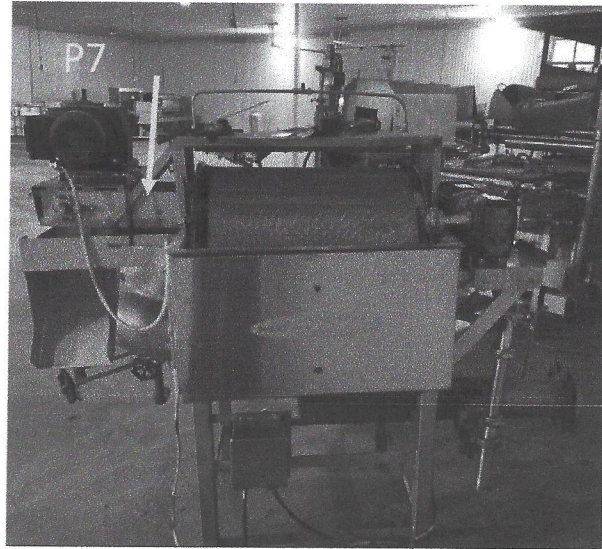
The DPF was in moderate condition with the drum drive and take-out drive is in place. The covers for the top were found with the associated ME section and the stack adapter. The compressed air blow off manifold was also intact. The DPF pull-out screen for fines discharge is missing and will need to be replaced. [Reference photo P7.](#)

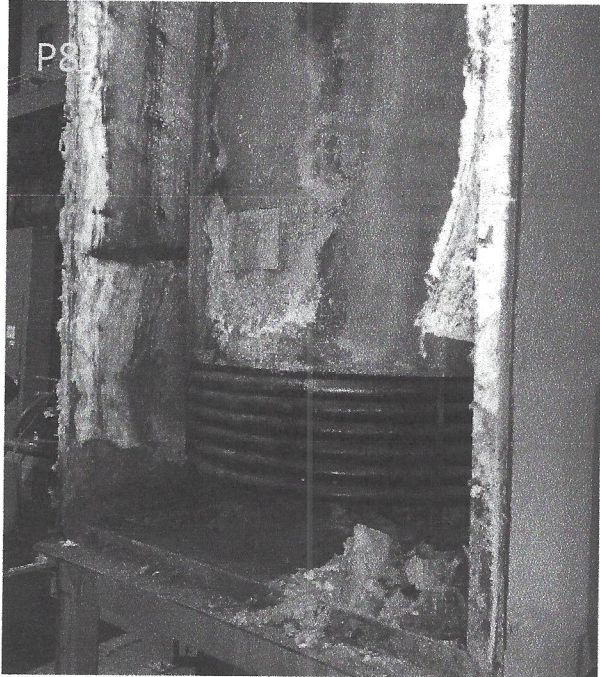
Interior case inspection revealed the insulation is in poor condition. The insulation is powdery in the bottom, pulling away from the casing and/or missing in other areas. [Reference photo P8.](#)

1. Remove the coil assembly from the heat exchanger.
2. Steam/chemical clean the coil.
3. Cap and pressure test the coil using compressed air at a low pressure of not more than 30 psi. This pressure should hold for at least 3 hrs.
4. If the coil leaks do not attempt to repair! A new coil must be purchased.
5. Remove all old insulation from the casing.
6. Inspect all anchor pins welded onto the casing replace as needed.
7. Reinsulate the casing, door and top pressure relief cover using H&C provided guidelines and materials.
8. Reinstall the old coil or install a new coil (depending on the result of the pressure test).
9. Reinstall the door and top pressure relief cover. Do not bolt the cover directly to the top of the casing, but install it using the existing chains, making sure the cover can lift several inches if needed as designed.
10. Finished.

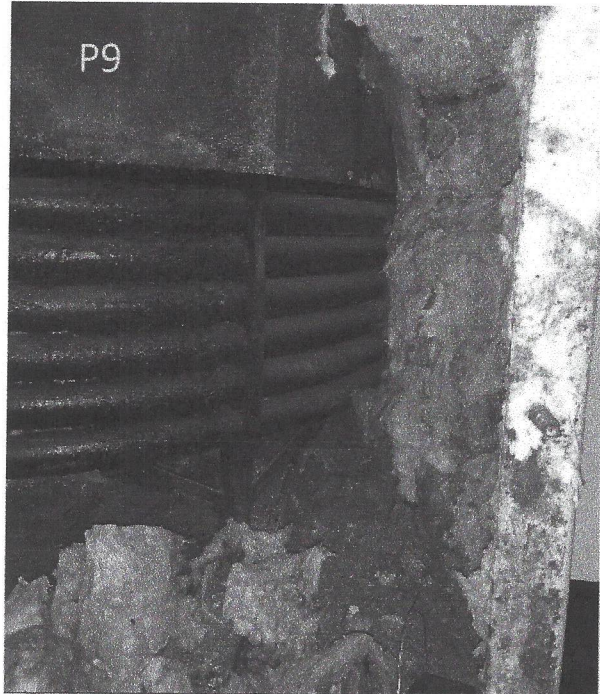
Case interior inspection revealed the coil shows signs of leakage. [Reference photo P9.](#)

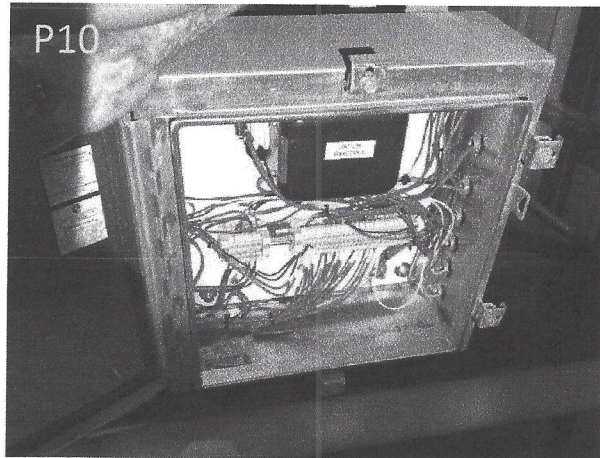
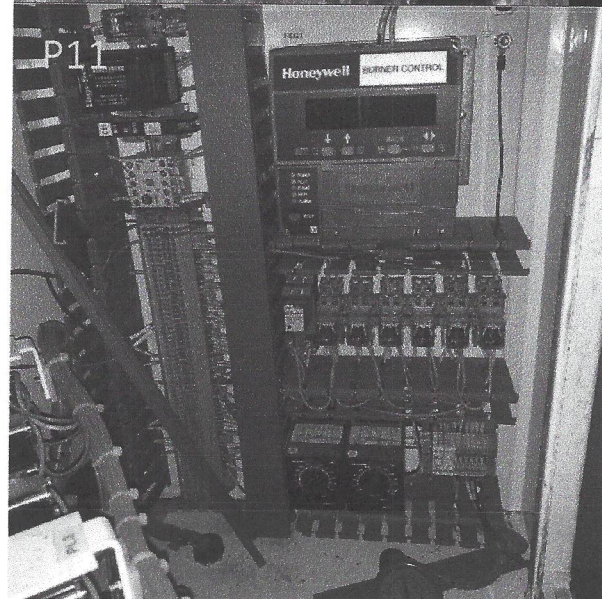
The heat exchanger control panel is in good visual condition with all wiring to components still intact. [Reference photos P10 and P11.](#)

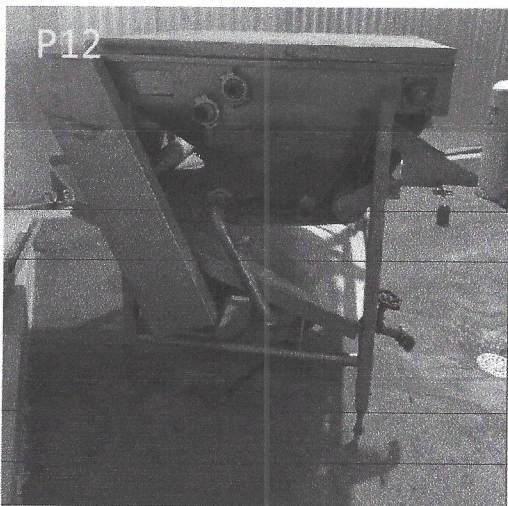
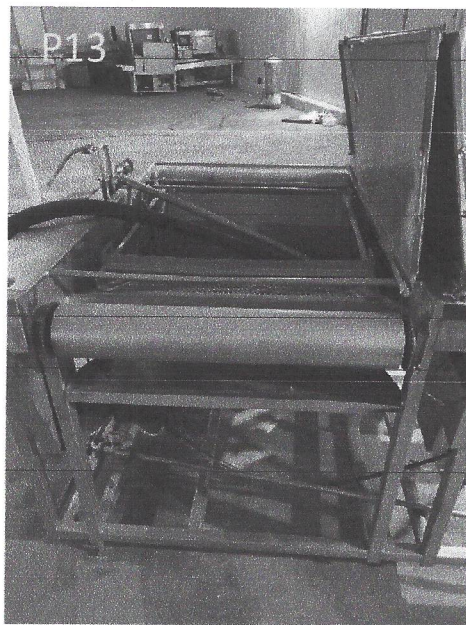
Reference photos P12 and P13 below:

CBF-36 Continuous Belt Filter, motor drives and suction pump were all present on the machine. The CBF was in good condition and very clean. The screen, motor drive, suction pump and all float switches were present on the CBF assembly. The transfer and supply pumps could not be found.

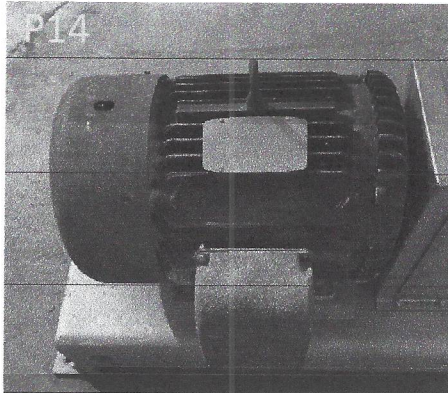
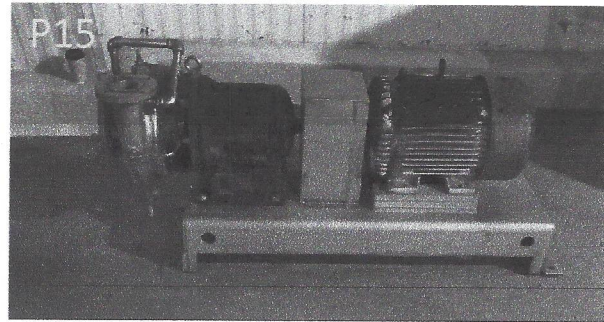
The pump was a bit rusty but in good condition. The pump could be turned by hand, and the coupling, base and motor were all intact.

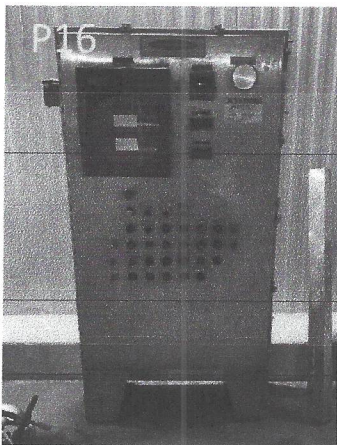
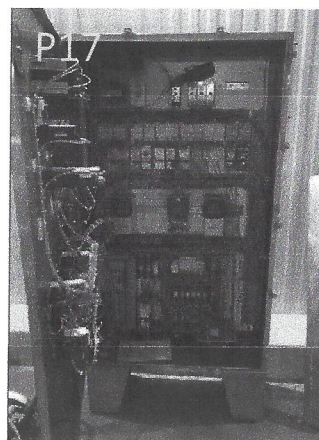
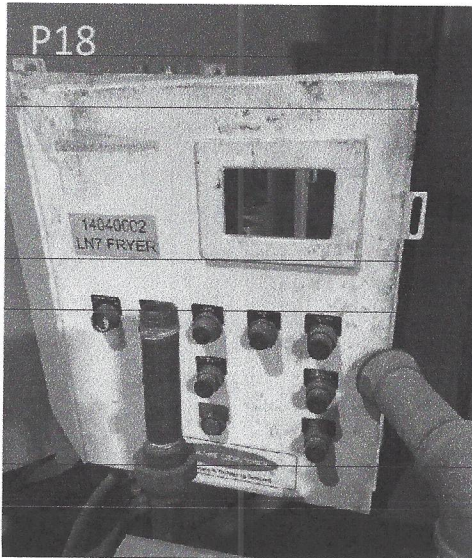
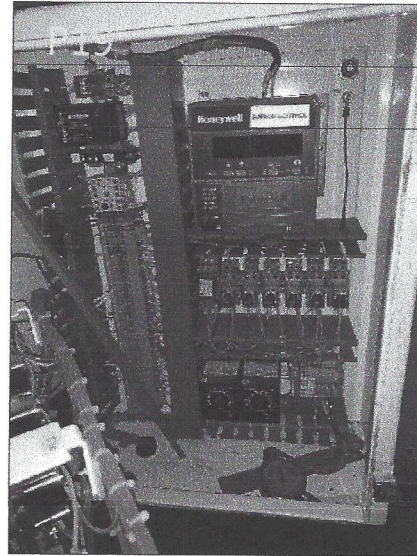
Both the fryer and the CTHX control panel look to be in good shape with minimal corrosion. Both panels are relay logic and do not have the current electrical safeties that are present in our newer systems. New sets of electrical prints were left with the customer for filed wiring as needed.
